Appendix A

A. Rehabilitation of Mechanical Systems At Wells, Pump Stations And Pipelines

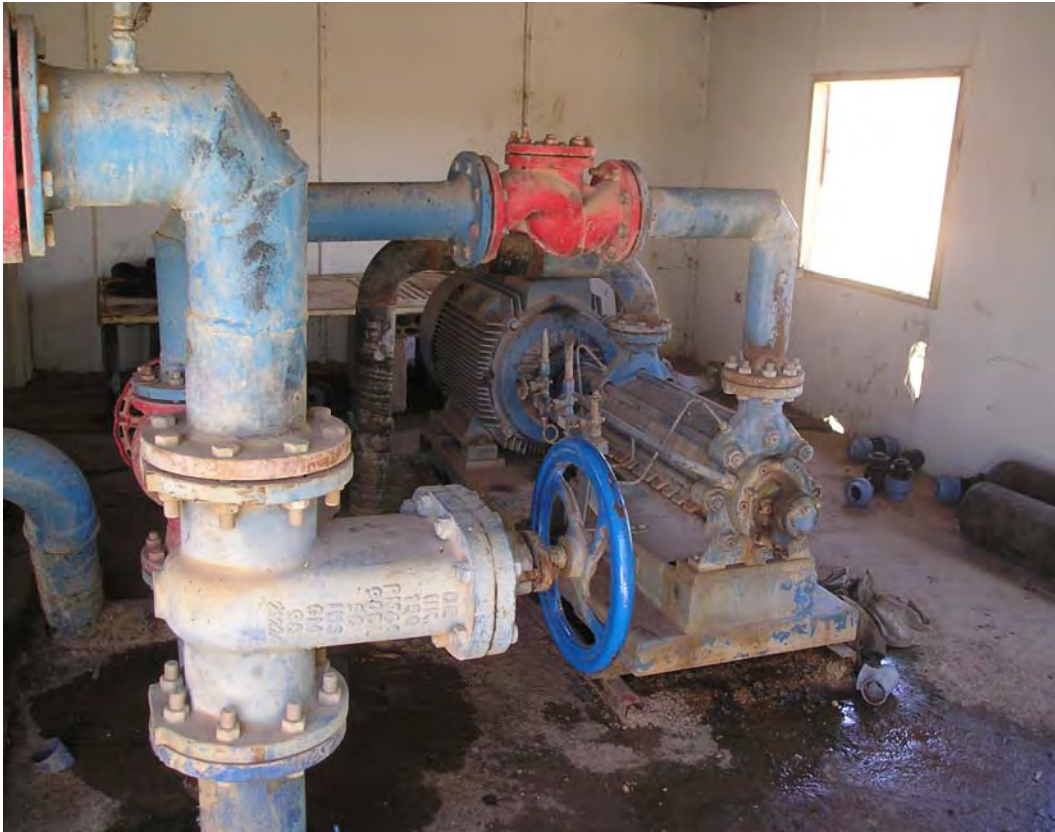
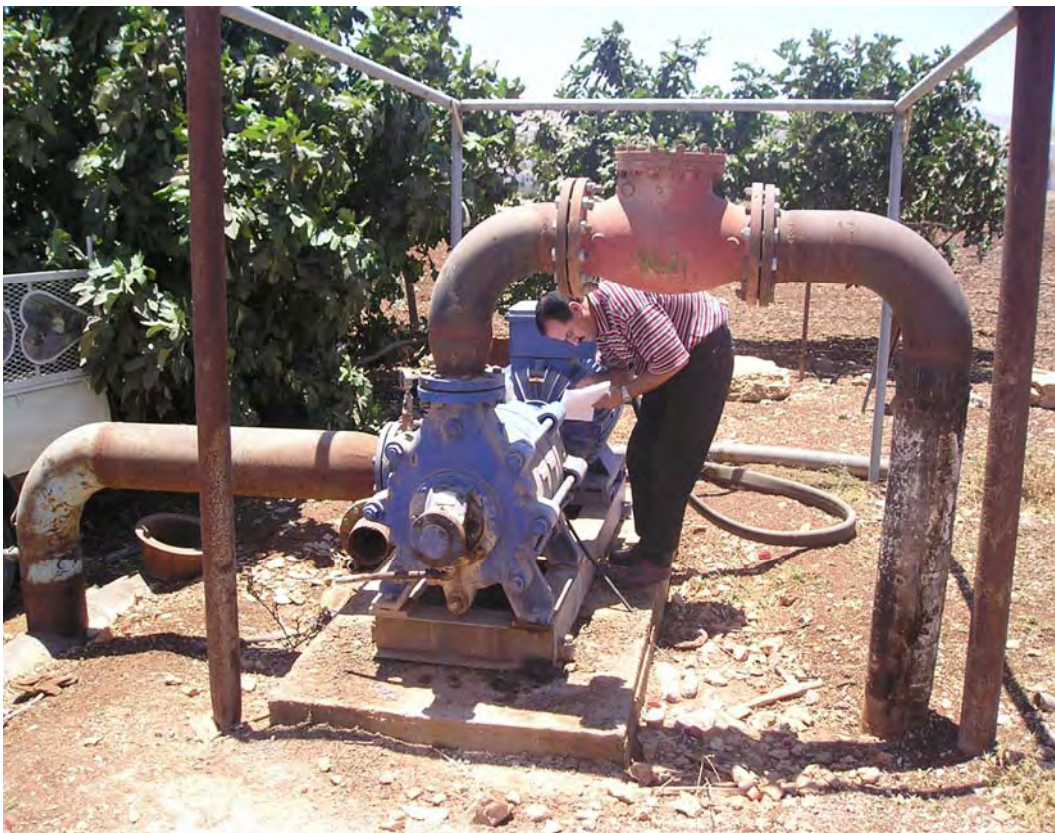
Figure A-8: Huson Pump Station

- Pumps are run manually.
- Flow control for each pump is done by throttling the isolating valve on the discharge side.
- Pumps and motors are rusty and dirty.
- Identification name plates for pumps & motors are unreadable, covered with paint and dirt.
- Coupling guards are missing.
- Pump glands are rusty and water leakage is excessive.
- Pump bearings are rusty.
- Pump-gland drains are blocked.
- Suction and delivery lines are poorly arranged, without pipe supports; a new pipe-work arrangement with valves and headers is needed.
- Air valves and pressure gauges on both suction and delivery lines are missing.
- Pump foundations are in very bad condition, for the two pumps inside the pump house.
- A new pump house building is recommended.

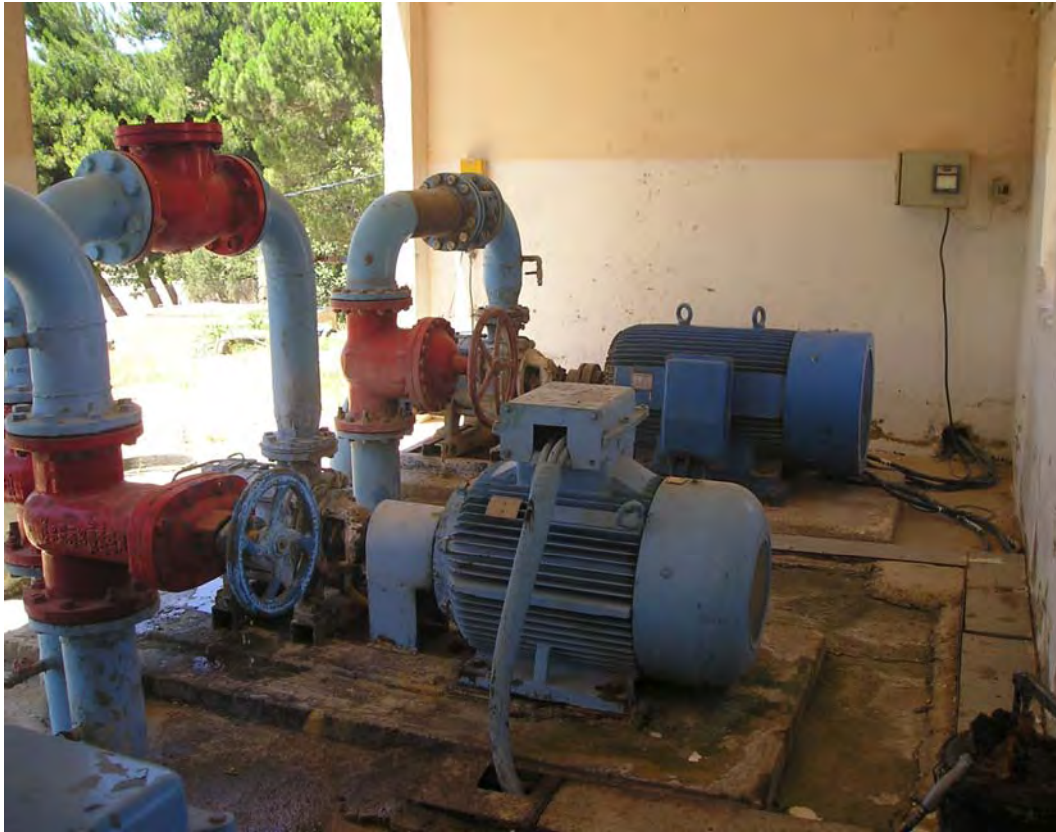
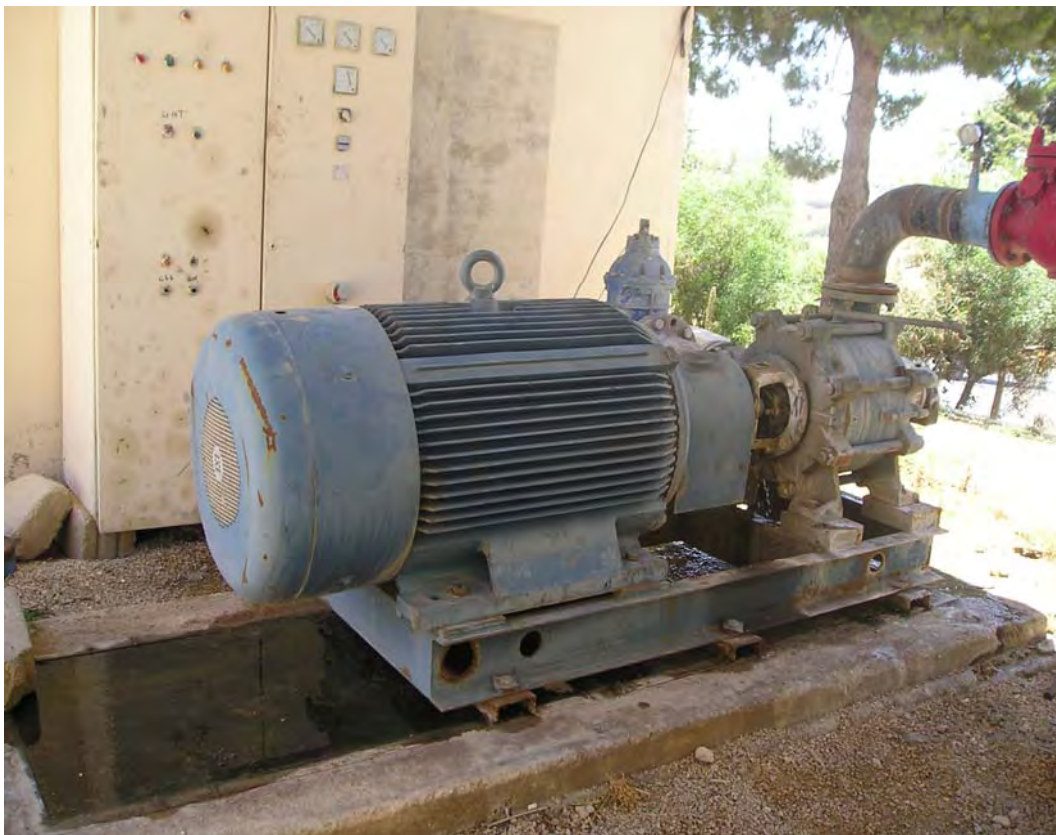
Figure A-9: Samad Pump Station

- Pumps are run manually.
- Flow from each pump is controlled by throttling the isolating valve on the discharge side.
- Pumps are rusty and dirty.
- Identification name plates for pumps & motors are unreadable, covered with paint and dirt.
- Coupling guards are missing.
- Pump glands are rusty and water leakage is excessive.
- Pumping-gland drains are blocked.
- Pump bearings are rusty.
- Air valves and pressure gauges on both suction and delivery sides are missing.
- New pumping units, equipped with flow control valves and suitable for parallel operation, are recommended.

- Suction and delivery pipes for all pumps are poorly arranged, without pipe supports; a new pipe-work arrangement, with valves on common headers on the suction and delivery sides, is recommended.
- Pump foundations are in bad condition; new foundations are recommended.
- The pump house is small, without a door; the floor is in bad condition, covered with contaminated water around the pumps. A new building providing more interior space is recommended.

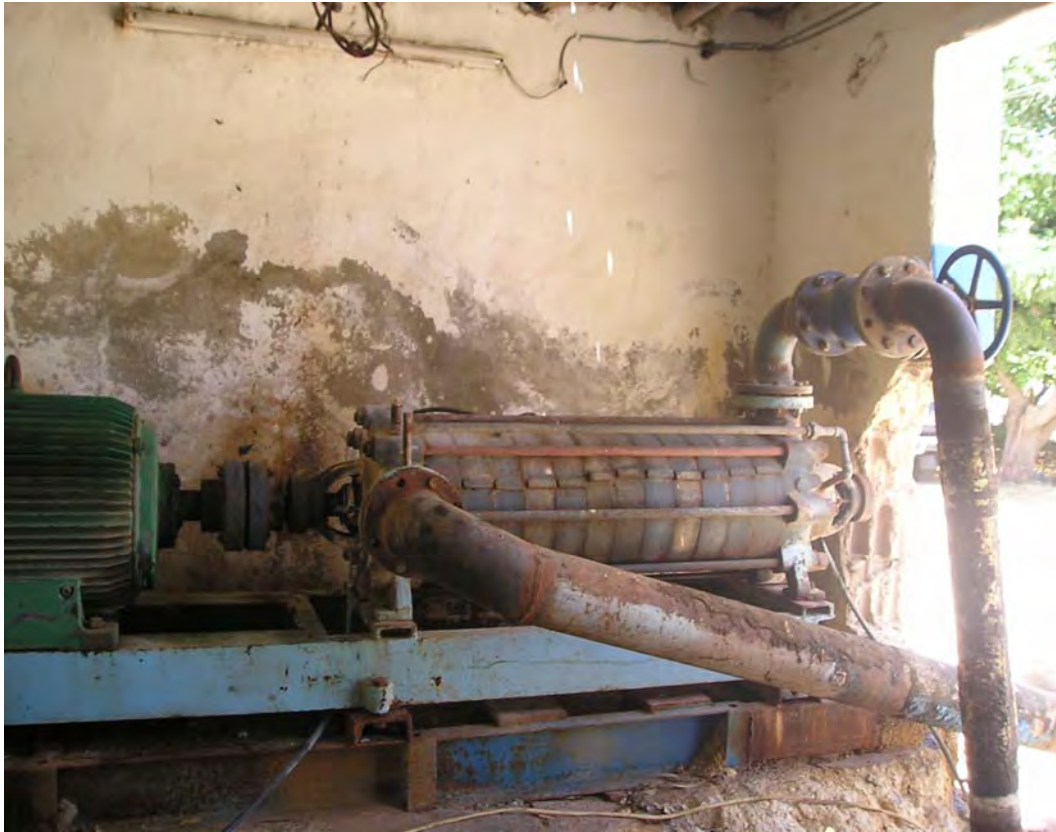
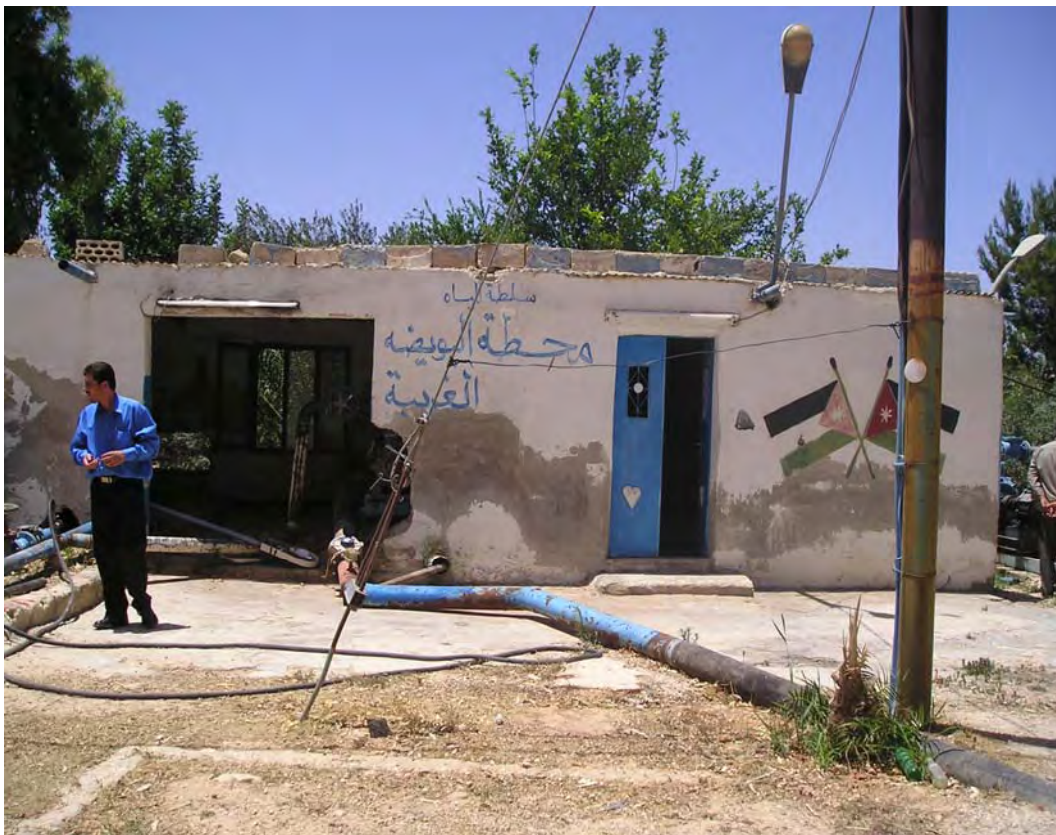
Figure A-10: Bwaydah Pump Station

- Flow control valves are missing.
- Flow control for each pump is done by throttling the discharge isolating valve.
- Pumps and motors are rusty and dirty.

- Identification name plates for pumps & motors are unreadable, covered with paint and dirt.
- Coupling guards are missing.
- Pump bearings are rusty.
- New pump units are recommended, equipped with control valves and suitable for parallel operation.

- Suction and delivery pipes for all pumps are poorly arranged, with incompatible pipe sizes, no pipe supports, corroded and leaking from joints; a new pipe-work arrangement is recommended, with common headers on both the suction and delivery sides.

- Isolating valves are in bad condition and need replacement.
- Check valves are in bad condition and need replacement.
- Air valves and pressure gauges on both suction and delivery are missing.

- Pump foundations are in bad condition; new foundations are needed.
- The pump house is small, without a door; floors are dirty and covered with contaminated water around the pumps; a new building with sufficient space for all the pumps is needed.
